Public Transport  
Authority

## INVESTIGATION REPORT

### FINAL REPORT

#### Level crossing collision Transperth Train Service 5604C and Swan Transit Bus TP 1593

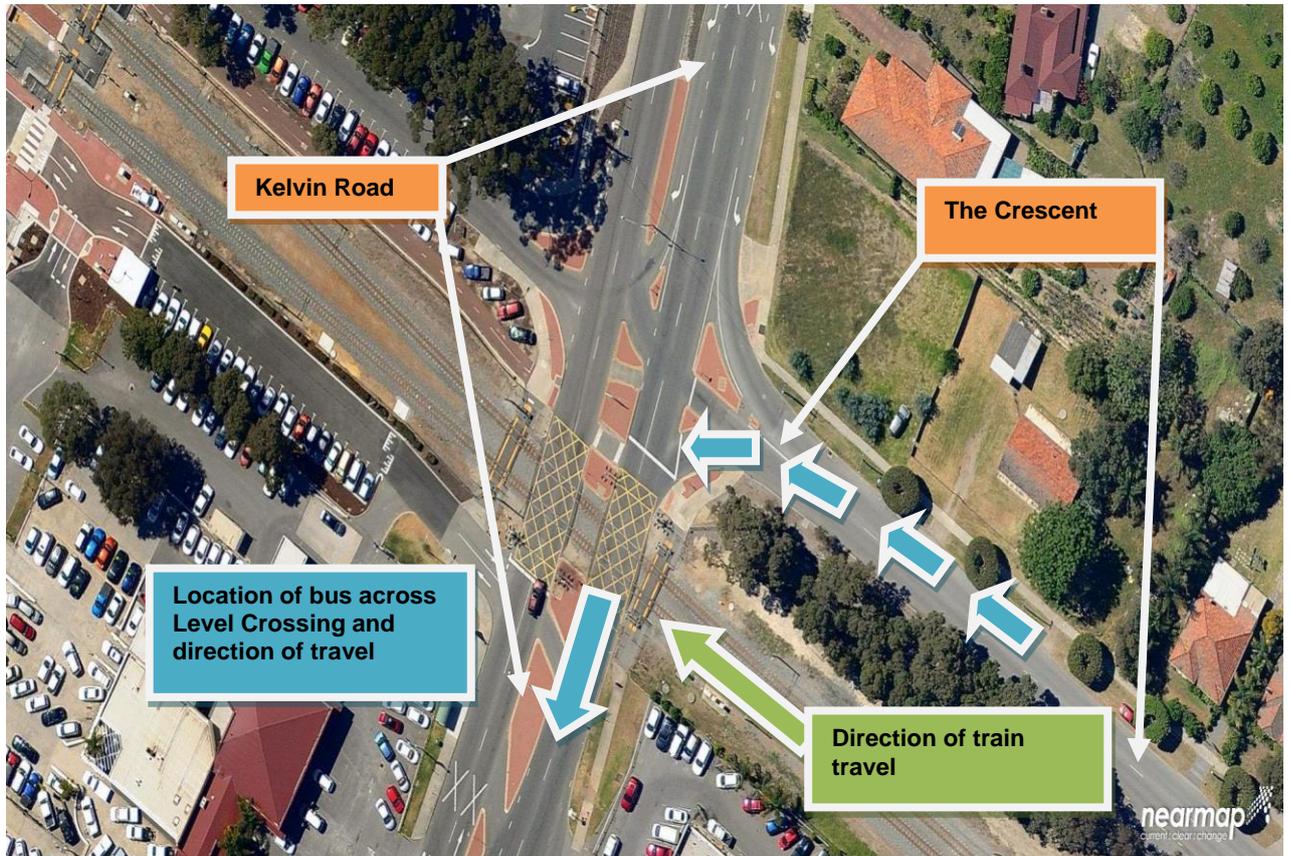
**Figure 1: Near map view of incident location**

The railway is designated as double line with exclusive up and down unidirectional main lines to facilitate train operations in each direction. The ruling gradient is 1 in 120 from Armadale to Kenwick, Figure 1 Page 18 refers.

Immediately prior to the level crossing for trains travelling towards the City is a protected pedestrian maze.

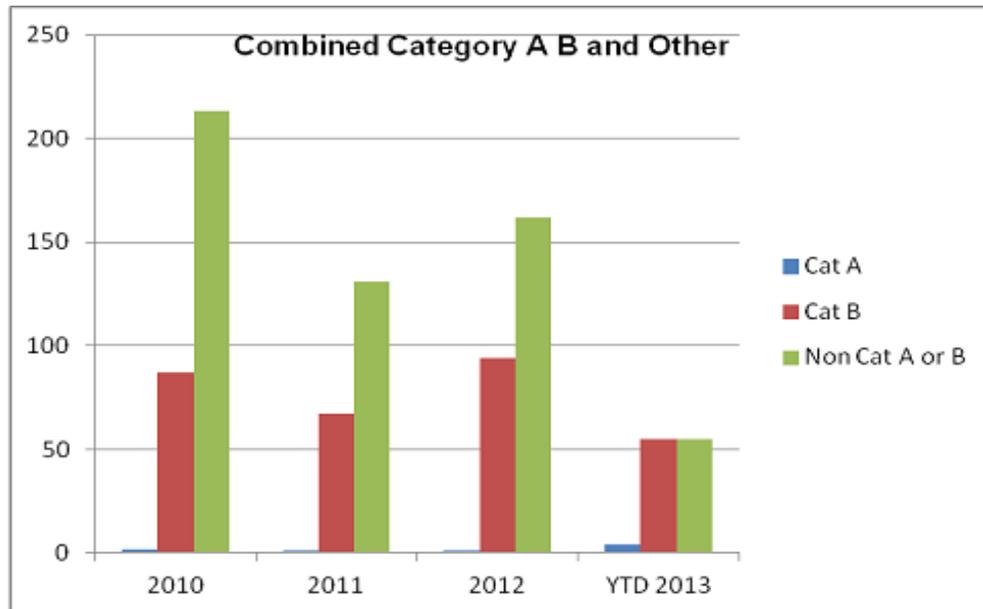
Figure 2 – Number of level crossing incidents since 1 January, 2010

Data drawn from the PTA Incident and Fault Reporting System (IFRS) for the PTA rail network demonstrates an overall reduction in level crossing incidents over the past four years as indicated at Figure 2, below.

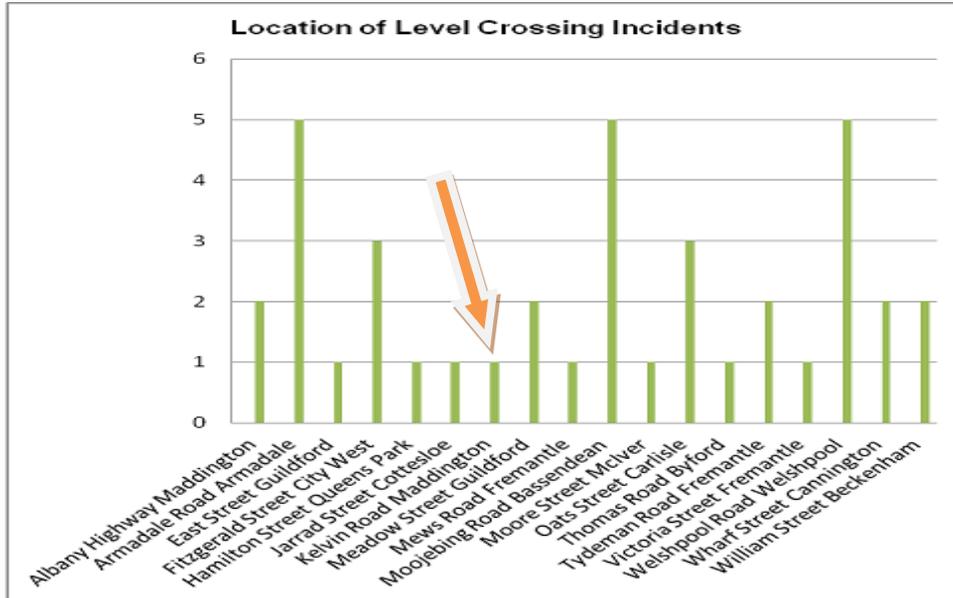
Figure 3 – Location of level crossing incidents since 1 January, 2010

The location and type of level crossing incidents is illustrated in the graphs at Figure 3 and 4, page 28.

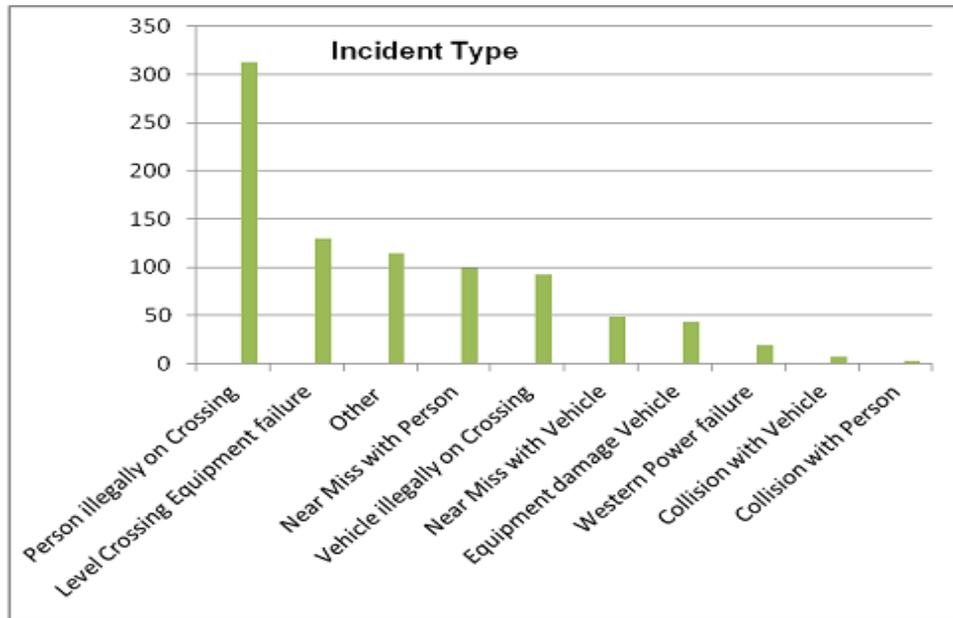
Figure 4 – Level Crossing incident type since 1 January, 2010

Review of the data indicates that there were no reported precursor events at the Kelvin Road level crossing involving road and rail traffic that would give rise to concerns about the safety of the crossing. There have been 6 collisions between trains and road vehicles across the PTA Network since January, 2010.
