INVESTIGATION REPORT

## Dewirement of Overhead Line Daglish Station 24 March 2014

**File:** PTA1181/14

**Incident Date:** 24 March 2014

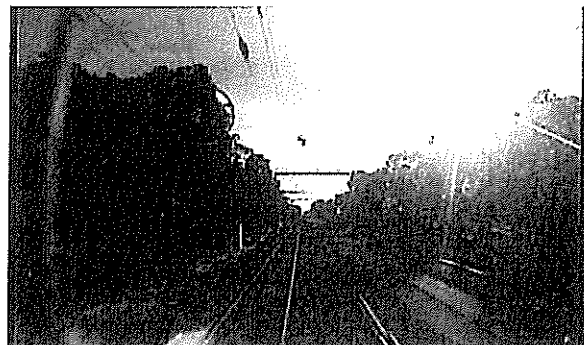
As service No 7543AS approached Daglish Station the railcar's forward facing camera shows a loss of tension in the Catenary System at 0757 hours. The balance weights were on the ground, which corresponds with the second SCADA event trip. As shown from *Figure 1* the three disc glass insulators can be seen hanging down because of the loss of tension. This confirms that further damage and loss of tension occurred during passage of service 7543AS.

*Figure 1: Still shot from forward facing camera of train service 7543AS*

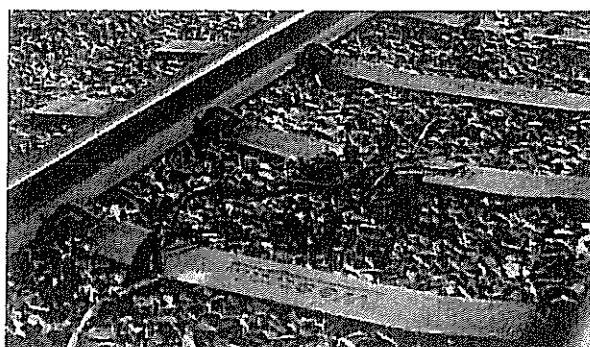
On inspection of the incident site a scorched branch was found in the middle of the Down Main in the overlap takeover span. This branch had clear evidence of blackened scorching on it. It is suspected that this was sustained over a period of time, indicating further arcing to the overlap span had occurred. High winds were recorded in the days leading up to the dewirement.

*Figure 2: photo of the location of the branch after the incident.*

A closer inspection of the branch found in the overlap span found that the leaves on the branch were fresh. This indicates that the branch had recently fallen from a tree in close proximity to the perway

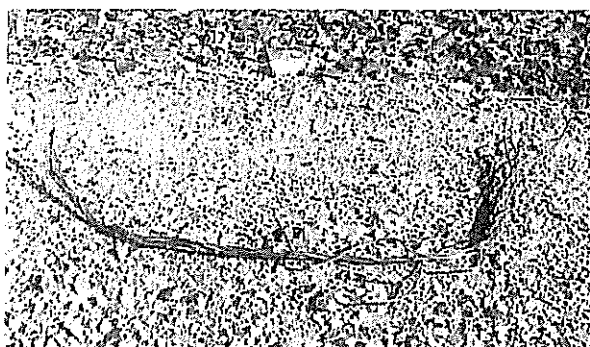
*Figure 3: photo of the section of Catenary Wire found*

A one metre section of the Catenary Conductor was found several metres into the overlap span. This section of the Catenary shows evidence of sustained arcing over a period of time [figure 3]. This has caused annealing which confirms that the parting of the Catenary was due to heat rather than mechanical failure.

A one metre section of Catenary Wire was found several meters into the overlap span. All strand ends show typical evidence of annealing, which confirm that the parting of the Catenary Wire was due to heat rather than mechanical failure. Some strands are worn from the pulley wheel but not sufficiently to have caused a dewirement. Hard drawn copper conductor can have 3 strands broken and still maintain full mainline tension.

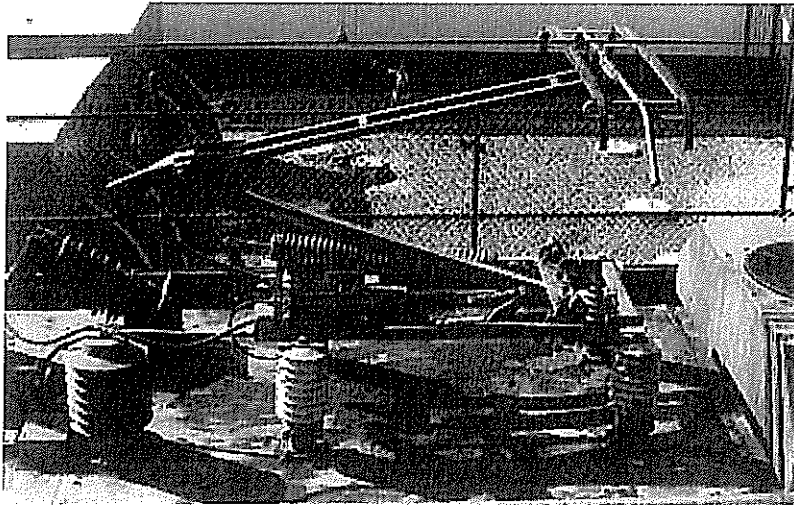
The Pantographs fitted to the "A" railcars are Schunk Model WBR 23L (refer Figure 4) have no secondary suspension or Automatic Dropping Device (ADD).

*Figure 4: SINGLE ARM PANTOGRAPH Model WBR23LK.*

Both Pantograph heads were severely damaged as a result of the dewirement.

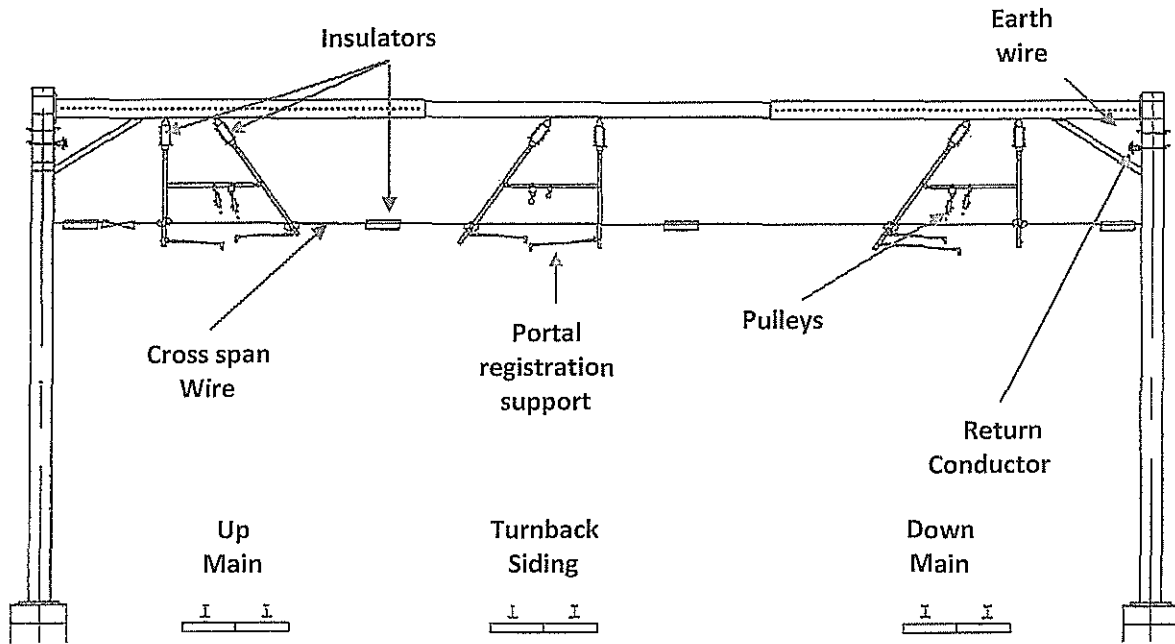
The portal registration support frames at Dalglish Station on the Down Main at Location F 7.278DU have pulleys attached that support the Catenary Wire. The Catenary Wire was run across the top of, and through, the pulley and not in accordance with the system design specifications for this type of arrangement. (Refer to Figure 5 and Figures 6 to 8 on subsequent pages).

Figure 5: Diagram showing Location F 7.278DU.

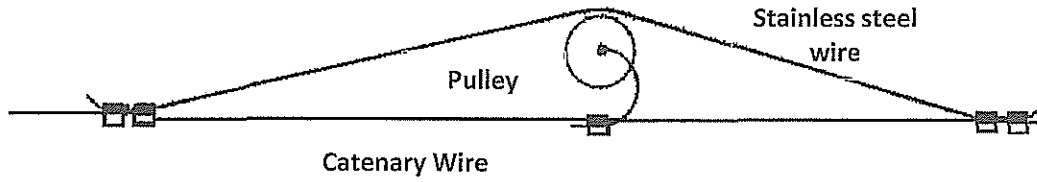
Figure 6: Diagram showing pulley assembly support in accordance with System drawing ES-HG-1757.

The "as-built" documents show that pulleys are required to be installed for the portal configuration. Drawing ES-HG-1757 [5] shows that when pulleys are installed a stainless steel "Bridle" is required.

The Bridle is used to ensure that the Catenary Wire is not in contact with the alloy pulley wheel to prevent arcing and undue wear on the Catenary Wire. (See figures 6, 7 and 8)

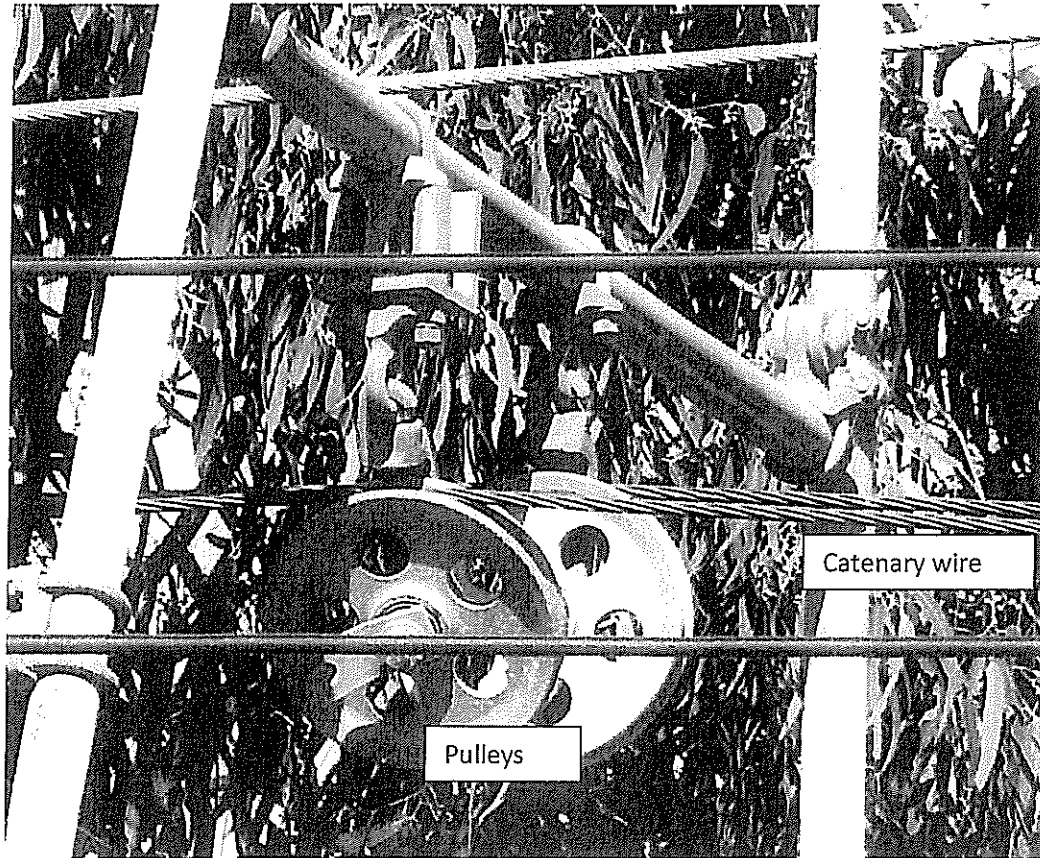
Figure 7: photo showing how the Catenary Wire was run through the pulley assembly support.

The design incorporates the use of stainless steel wire Bridles that run through the pulley system. Stainless steel is a much stronger and harder wearing metal than the seven strand copper Catenary Wire. Running copper Catenary Wire through pulley wheels is not recommended because the pulley wheels can be different in their mechanical makeup and composed from different alloys, they are not bimetallic.

The absence of stainless steel Bridle arrangements (not installed by the enhancement project) has given rise to localised minor arcing over a sustained length of time. Although the Catenary Wire does show minor wear on the strands from passing through the pulley wheel, it is the tree branch that led to the final catastrophic failure of the Catenary Wire. [10]

- All similar locations that included portals on the network were reviewed for compliance with the system design; no other locations were identified with the same issue.
- The overhead team has been fully briefed on the importance of stainless steel Bridles at pulley wheels, especially at insulated overlaps.
- A maintenance alert regarding midpoint and catenary suspension pulleys has been issued to the overhead maintenance team.
- Key engineering roles have been identified to ensure that there is full ownership across all of the areas of design, installation and commissioning.
- New Procedure for Engineering Assurance for Projects.

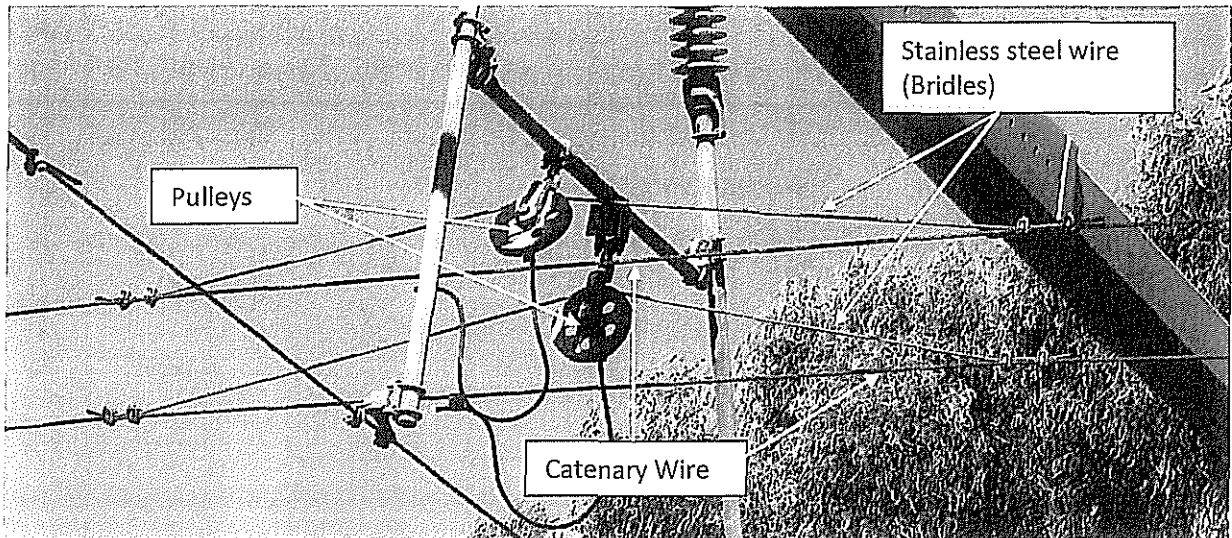
Figure 8: photo showing how the Catenary Wire is supported in accordance with the system design.
