ANALYSIS REPORT

INVESTIGATOR	David Bazen	FILE REF.	9/31119
CLIENT REF.	16/9364/STP	REPORT DATE	14/03/16
COMMISSIONED BY	Insurance Commission of WA		
INTEREST	Insurer		
THIRD PARTIES	Nil		
ATTACHMENTS	Nil

INCIDENT DATE	Multiple	INCIDENT TIME	
TYPE OF INCIDENT	Fire		
LOCATION	Multiple		
OWNER	Department of Education		
OCCUPIER	As Above		
DAMAGE	Fire damage to air conditioning unit and building structures		
USE OR APPLICATION	Mechanical Services

- 1.1. We have been engaged by the Insurance Commission of Western Australia to conduct investigations into multiple fires occurring with evaporative air conditioners at Department of Education sites over the previous 18 months

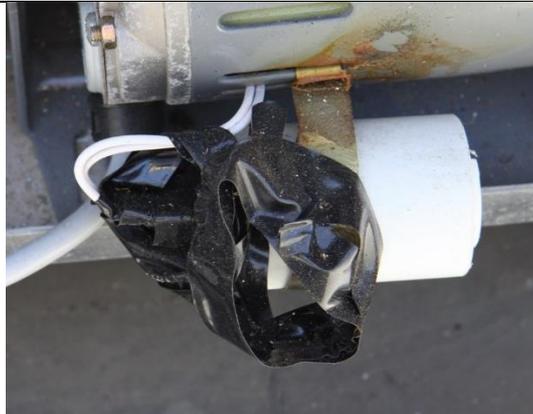
4.34. However, we have found firm evidence of poor installation/repair practices as seen in RSHS and shown in Fig.1.

<p>AC 12</p> <p>Motor capacitor missing plastic cover and live terminals insulated (poorly) with insulation tape</p>

- 4.38. Given these two issues were detected directly on either side of a fire involving the same type of unit we can conclude that the units involved in the fire were highly likely to have contained similar defects prior the incident.

- 4.39. This type of situation arises (for example) where the service technician breaks part of the control box (normally as they become brittle with age) whilst trying to access it for repairs, leading to a quick-fix repair to get the job completed rather than obtaining the correct parts and returning at a later date.

- 6.3.5. Inspection of all electrical cabling and components and rectification of poor workmanship and/or broken covers and protective structures
- 6.4. Specific instructions are issued to ensure that all repairs to be undertaken must restore the unit to OEM standard condition and that all parts used must be genuine OEM components or OEM approved after-market alternatives.

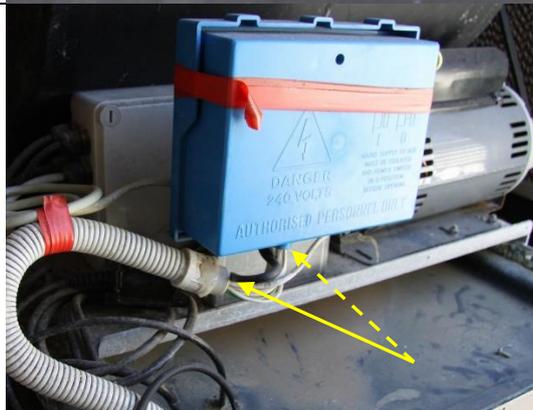
<p>AC 07</p> <p>Insulation tape retaining control box lid due to broken clips and conduit gland not fitted to base of control box</p>

4.36. It must be noted that the issue with the poorly fitted gland in AC 07 is likely to be related to the original installation of the unit, however it would be expected that the maintenance contractor would detect this issue and make arrangements to have it rectified at some point.

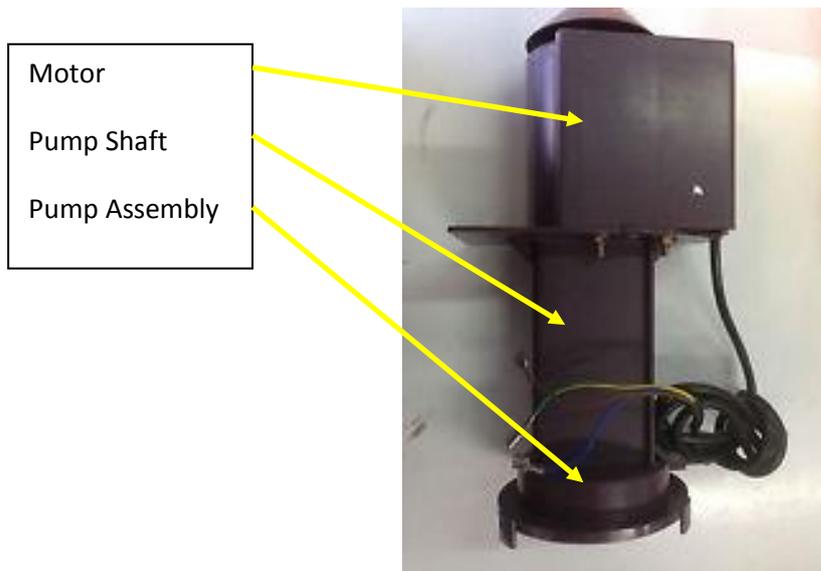
Fig.2 – Evaporative Air Conditioning Pump

- 4.59. Both the Bonaire and Bravis systems uses a vertical stack centrifugal pump (as per Fig.2) manufactured by JRM, as brand of Fasco (USA), who manufacture a large number of refrigeration and air conditioning products.

- 4.60. These pumps have a limited life in service due to the harsh internal operating environment of the air conditioning unit, generally considered to be between 2 – 5 years.

- 4.61. The most common cause of breakdown is mechanical seizure of the pump and shaft assembly through wear to the bottom bearings causing eccentric operation or moisture ingress and/or corrosion to the top bearing assembly.

- 4.62. In addition, where the pump is left inactive for extended periods (during winter and during school holidays) the lack of movement causes stagnation of the bearing lubricants that can lead to hardening and seizure, further augmented by corrosion from trapped water.

- 4.65. It is therefore a common finding for the pump to be seized and the top casing melted due to the motor being energised in locked rotor conditions without any means to remove the excess heat.

- 6.6. Subject to OEM discussion and review, option to replace existing vertical stack pumps with either submersible or thermally fused pumps at the time of failure, noting the level of risk reduction does not justify retrofitting of existing working systems.

- 6.13. An alternative to submersible pumps is the potential selection of pumps using a thermal fuse as opposed to an auto-reset overload, which will permanently isolate the pump from the supply in the event of overload thus minimising the potential for burn out with a continuous reset cycle.
