Fremantle Traffic Bridge 0916

PIER 15 EMERGENCY REPAIR

Project no: 2113438A-TPT-REP-0001 RevD

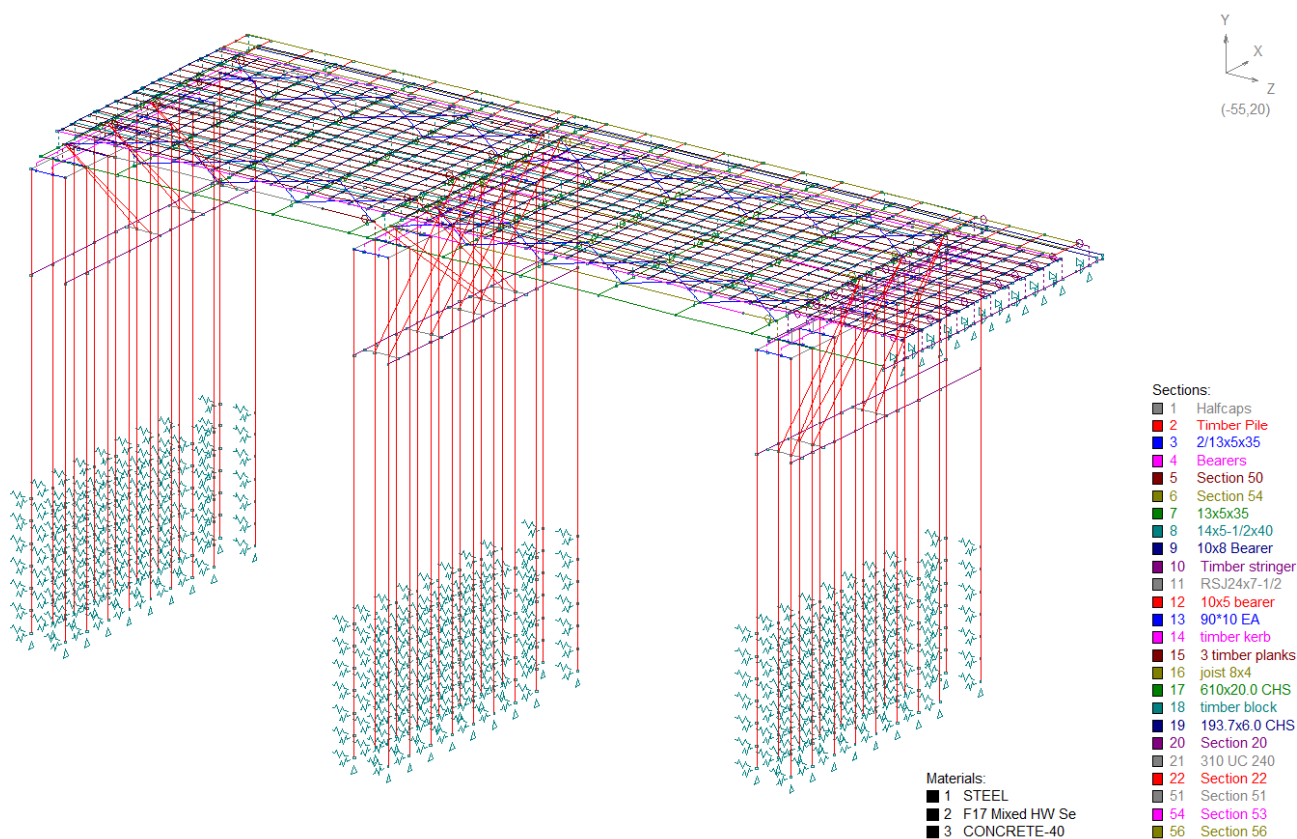
Plate 1: 3D Space Gass model – 1 timber span, 70ft & 56ft navigation spans

Two spans and the pier were modelled in SpaceGass as 3-dimensional frames (refer to Plate 1), based upon available as-constructed records.

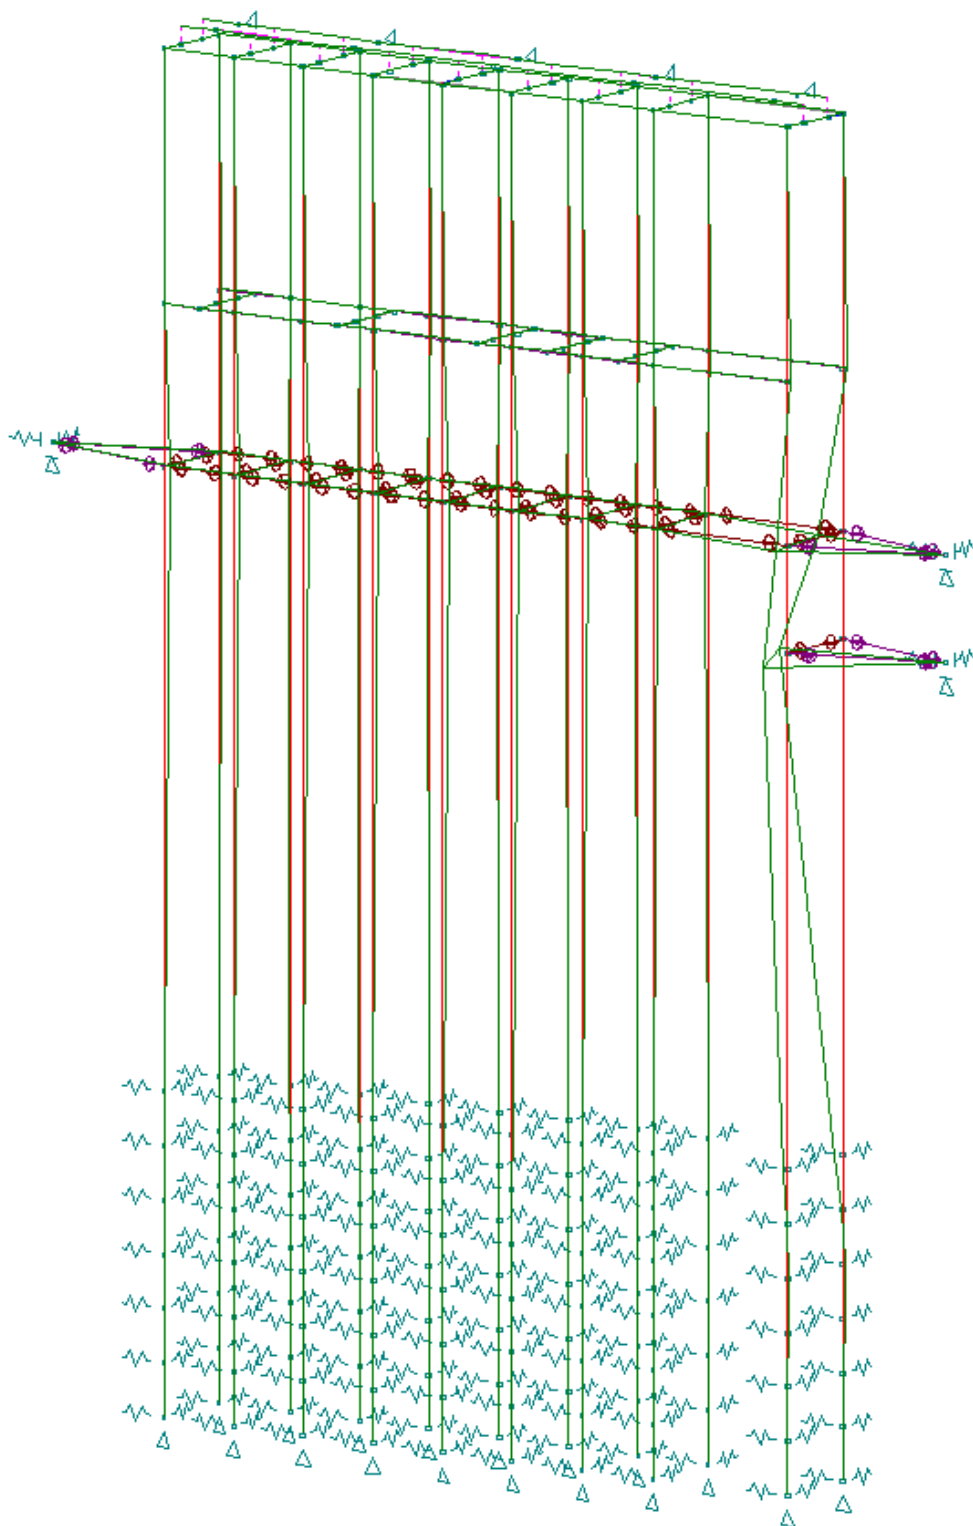
Plate 2: Pier 15 buckling model

A 3D model of Pier 15 (refer to Plate 2) was used to determine the effectiveness of the plan bracing and to confirm the reduction in effective length for each individual pile.

The member capacities of the timber piles were assessed with the reduced effective length. It was found that due to the lower river bed level at Pile 9A, bracing at one level was insufficient. The capacity of this pile was improved with the installation of a second plan bracing system installed to Piles 9A and 9B and connecting to the stiff fender pile at a further 3m below the first plan bracing level.
