REPORT 14
STANDING COMMITTEE ON PUBLIC
ADMINISTRATION

UNASSISTED FAILURE

January 2012

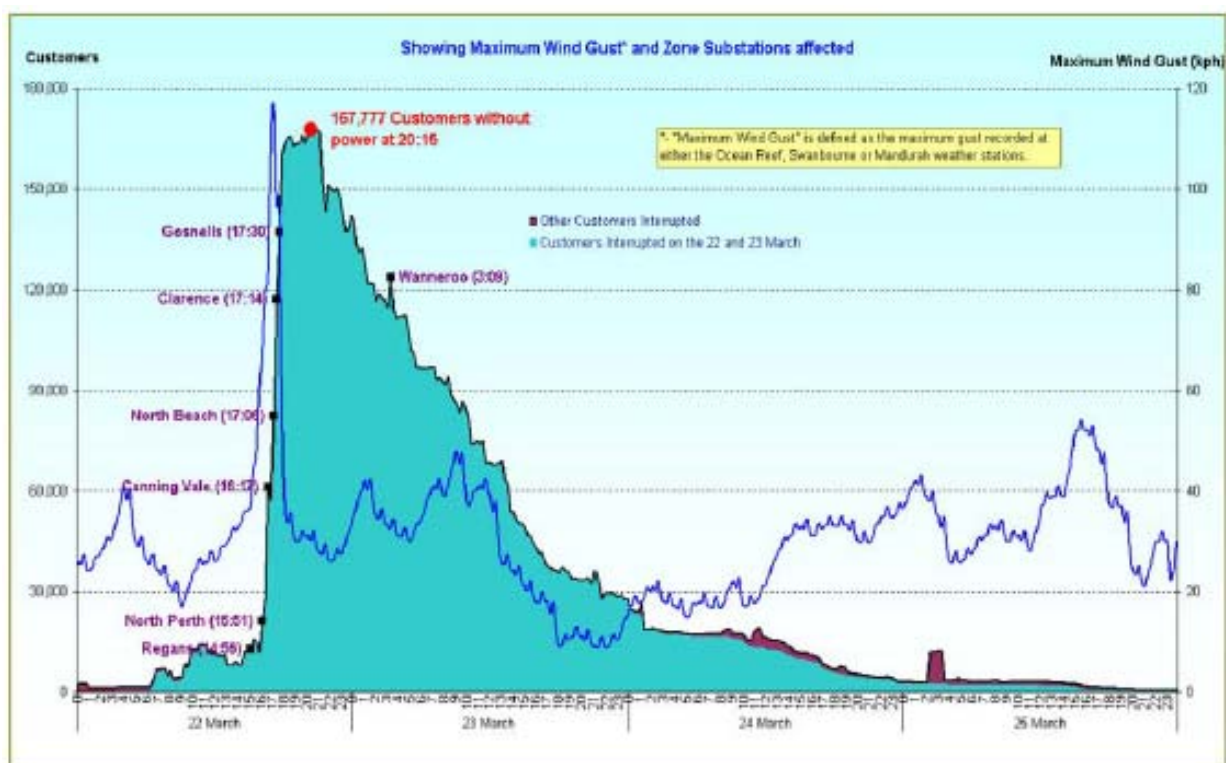
Figure 98: Number of customers affected by the March 2010 storm

- 7.86 The Committee acknowledges the severity of the March 2010 storm to which the above extract applies. However, Western Power has attempted to characterise it technically as a “*force majeure event*” with the result being that Western Power would be free to recover the costs incurred from its network customers. Presumably, to the extent that the damage claimed from the storm was the loss of failed network wooden power poles, such a claim is, perhaps, understandable, given that these are uninsured.

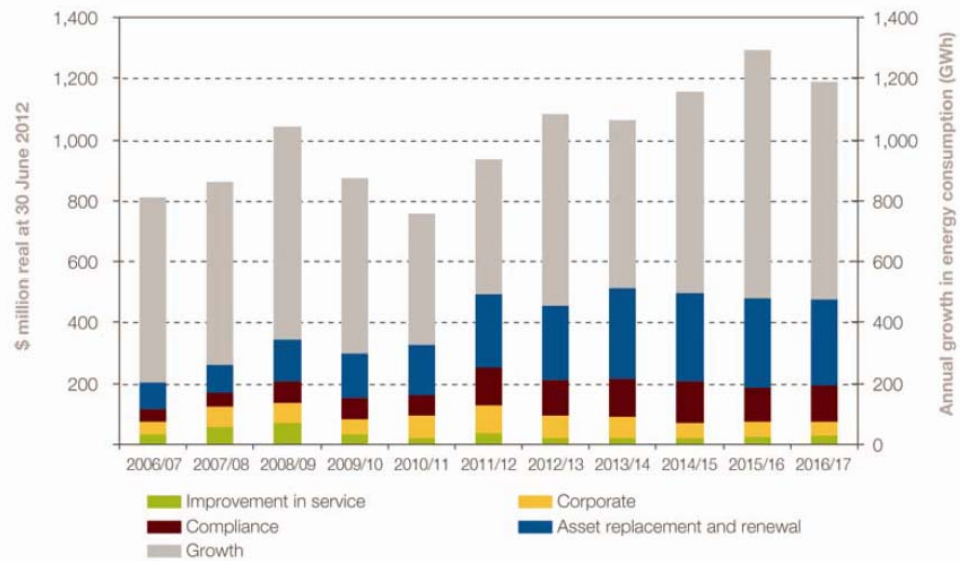
Figure 86: Total capital expenditure compared to history by regulatory category

8.40 Cursory reference to these graphs suggests strongly that Western Power has not invested adequately in either compliance or asset replacement prior to the AA3 period. As Western Power explains in its AA3 submission to ERA, it will be appreciated from each of these graphs that:⁴⁰³
