**THIRTY-EIGHTH PARLIAMENT**

**REPORT 14**  
**STANDING COMMITTEE ON PUBLIC**  
**ADMINISTRATION**

**UNASSISTED FAILURE**

January 2012

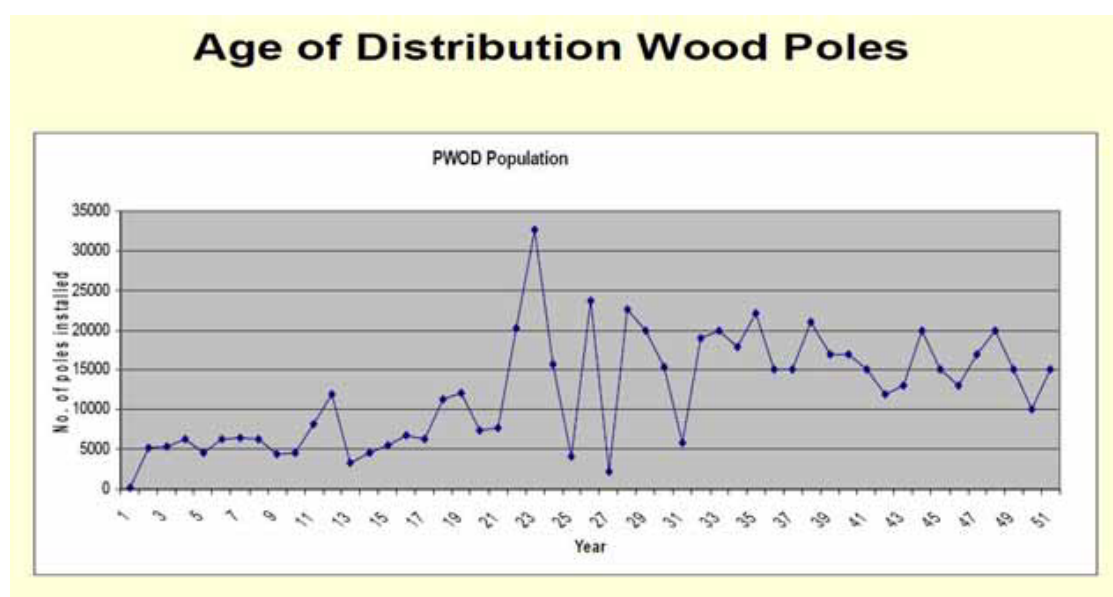
- 5.37 EnergySafety's 2008 Audit reported Western Power's own data relating to the age distribution of the wooden power poles in the South West Interconnected Network (SWIN), by means of the following chart, taken from an internal Western Power operational presentation:<sup>145</sup>

- 5.38 The Committee notes from the above chart that, as at May 2009, around a third of the wooden power pole asset base of Western Power appeared to be in excess of 28 years in age. The Committee also notes that, on the basis of its investigation, EnergySafety concluded in 2009 that; *"All the poles older than about 28 years are untreated jarrah*

- 5.39 One inference that EnergySafety identified based on its 2008 Audit, was that Western Power should have focused its wooden power pole replacement and reinforcement program on the right hand portion of the above chart, namely; those untreated Jarrah wooden power poles that had been in place for more than 28 years (see paragraphs 3.54 above, and 5.121 below). The 2008 Audit suggested prudent practice might require that a program of replacement and reinforcement should commence with the oldest untreated jarrah wooden power poles, and work to progressively replace this component of the wooden power pole asset base in line with industry standards. It is of some concern, therefore, that EnergySafety reported in its 2008 Audit that; “[t]his focus is not evident in Western Power’s SWIS Distribution Asset Management Plan 2008/09-2017/18.”<sup>148</sup>

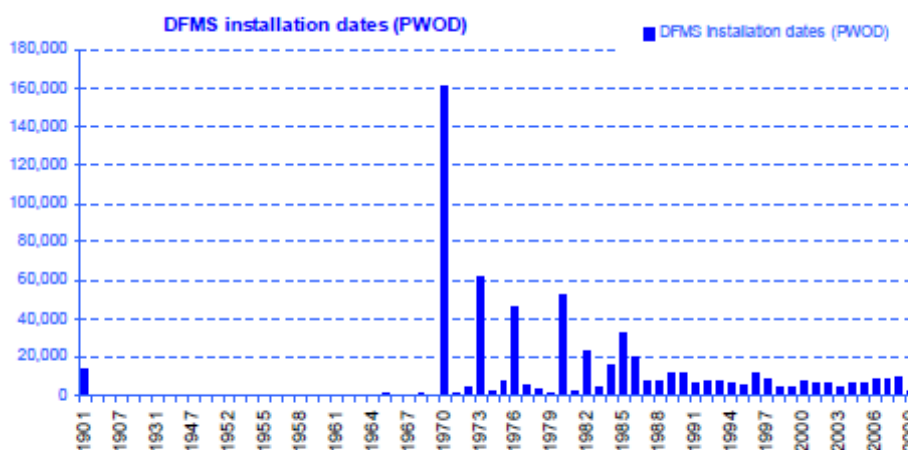
Figure 9: Present PWOD population based on the DFMS

- 5.41 The above chart suggests that the DFMS may not be able to provide accurate information regarding the location and age of approximately 160,000 of Western Power's individual untreated jarrah wooden power poles.

- 5.40 Any focussed wooden power pole replacement program by Western Power directed towards its untreated jarrah wooden power pole assets using the age of those wooden power poles as a material deliberative factor, would require detailed information about the location of Western Power’s oldest untreated jarrah wooden power poles. Western Power’s “Distribution Asset Management Plan for 2009/10” contains the following chronological chart indicating the installation dates for distribution wooden power poles, based on data generated by Western Power’s DFMS (see also paragraph 7.7 below):<sup>149</sup>

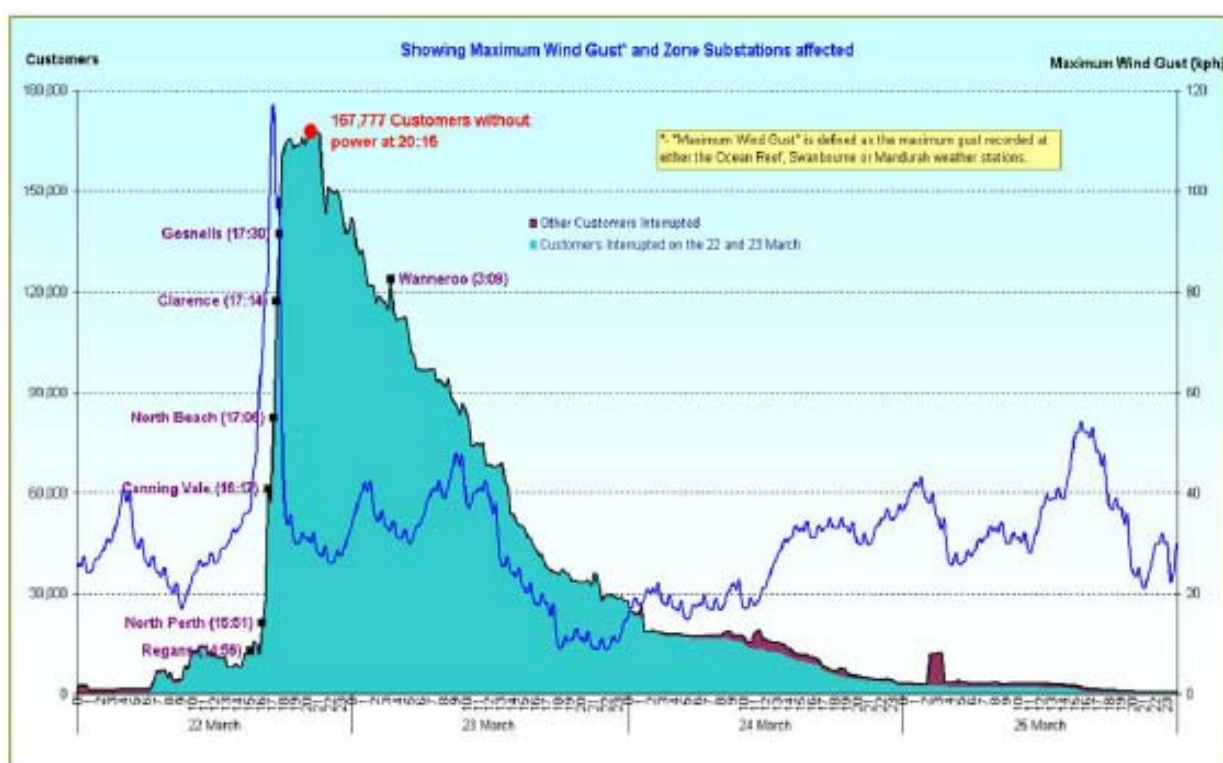
*The asset management system shortcomings that were identified in the 2006 Audit ... appear to have hampered Western Power's ability to mount a persuasive business case, for the increased expenditure, with the ERA.*

*On Monday 22 March 2010, a severe storm front passed over Perth bringing heavy rainfall, hail and strong winds up to 120 kilometres per hour. The Bureau of Meteorology reported rainfall up to 45 millimetres in some areas, significant lightning activity and the largest hail known to have occurred in Perth, all of which caused significant damage. The storm caused severe disruptions to the network. In total, power supplies for approximately 250,000 customers were affected and around 8000 MWh of load was unavailable for 31 hours. Figure 98 demonstrates the severity of the storm which affected six substations, contributing to the peak of 167,777 customers with interrupted supply.*

- 7.86 The Committee acknowledges the severity of the March 2010 storm to which the above extract applies. However, Western Power has attempted to characterise it technically as a “*force majeure event*” with the result being that Western Power would be free to recover the costs incurred from its network customers. Presumably, to the extent that the damage claimed from the storm was the loss of failed network wooden power poles, such a claim is, perhaps, understandable, given that these are uninsured.

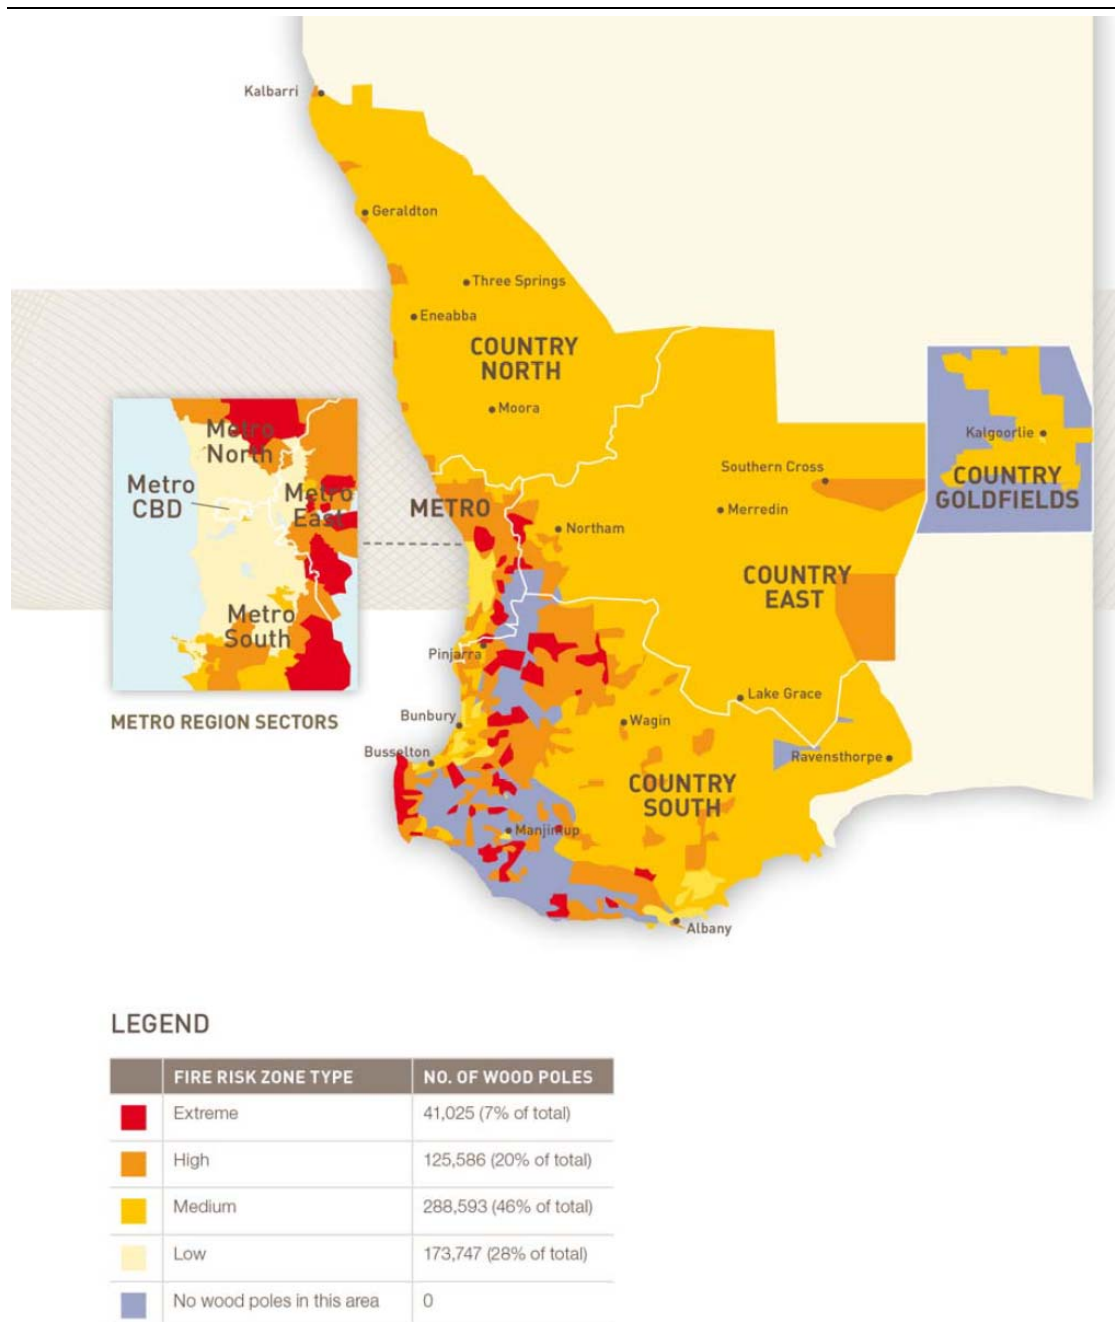
**Figure 73: Number of wood poles by fire risk zone in the Western Power Network**

*There are 176,000 wood poles located in 'extreme' or 'high' bushfire risk areas. A failed wood pole presents multiple hazards – it can harm people or damage property. Energised power lines contacting the ground can also cause electric shock and, in very specific conditions, cause fires. Figure 73 illustrates the fire risk zones across our network and the number of poles in each zone.*

*Our objective is to replace or reinforce any unsafe pole before it falls. Wood poles are usually serviceable for 40 to 50 years. More than 200,000 of our 630,000 wood poles are over 40 years old. Our pole failure rate is the highest in Australia by a significant margin because of the overall condition of our poles.*

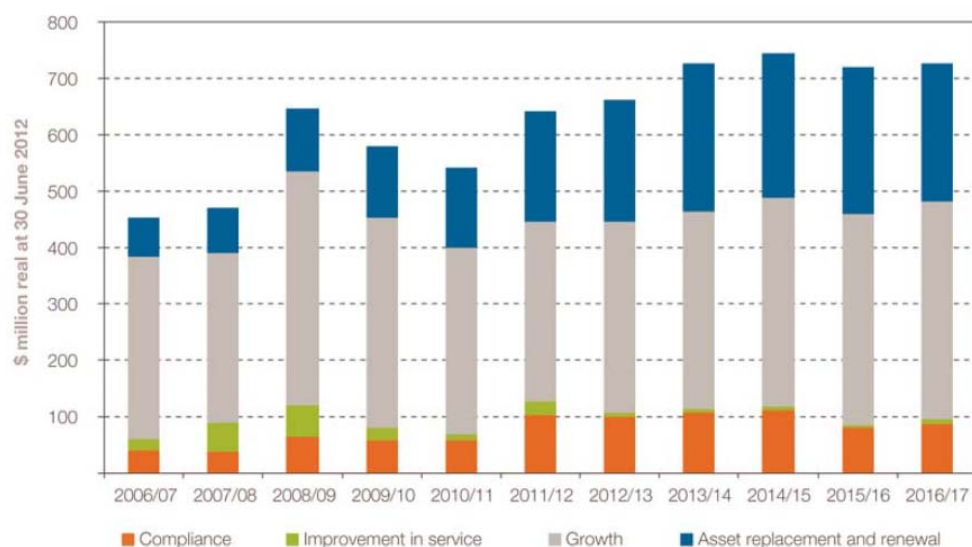
**Figure 82: Total distribution capital expenditure by regulatory category**

*Cursory reference to these graphs suggests strongly that Western Power has not invested adequately in either compliance or asset replacement prior to the AA3 period.*

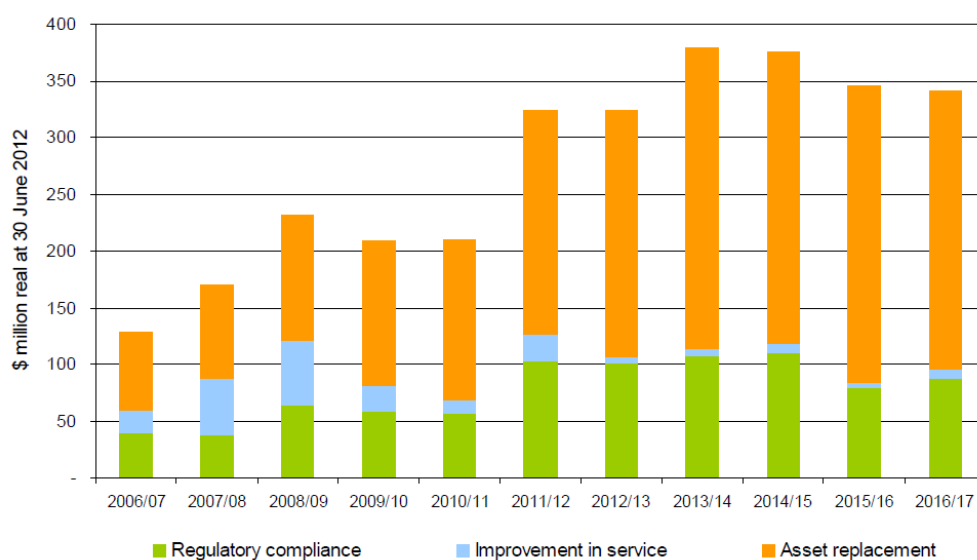
**Figure 84: Distribution non-growth capital expenditure by regulatory category**

- 8.40 Cursory reference to these graphs suggests strongly that Western Power has not invested adequately in either compliance or asset replacement prior to the AA3 period. As Western Power explains in its AA3 submission to ERA, it will be appreciated from each of these graphs that:<sup>403</sup>
