Rottnest Island Authority

Review into Army Jetty partial collapse

Engineering assessment and review of asset maintenance practices over the Army Jetty

February 2019

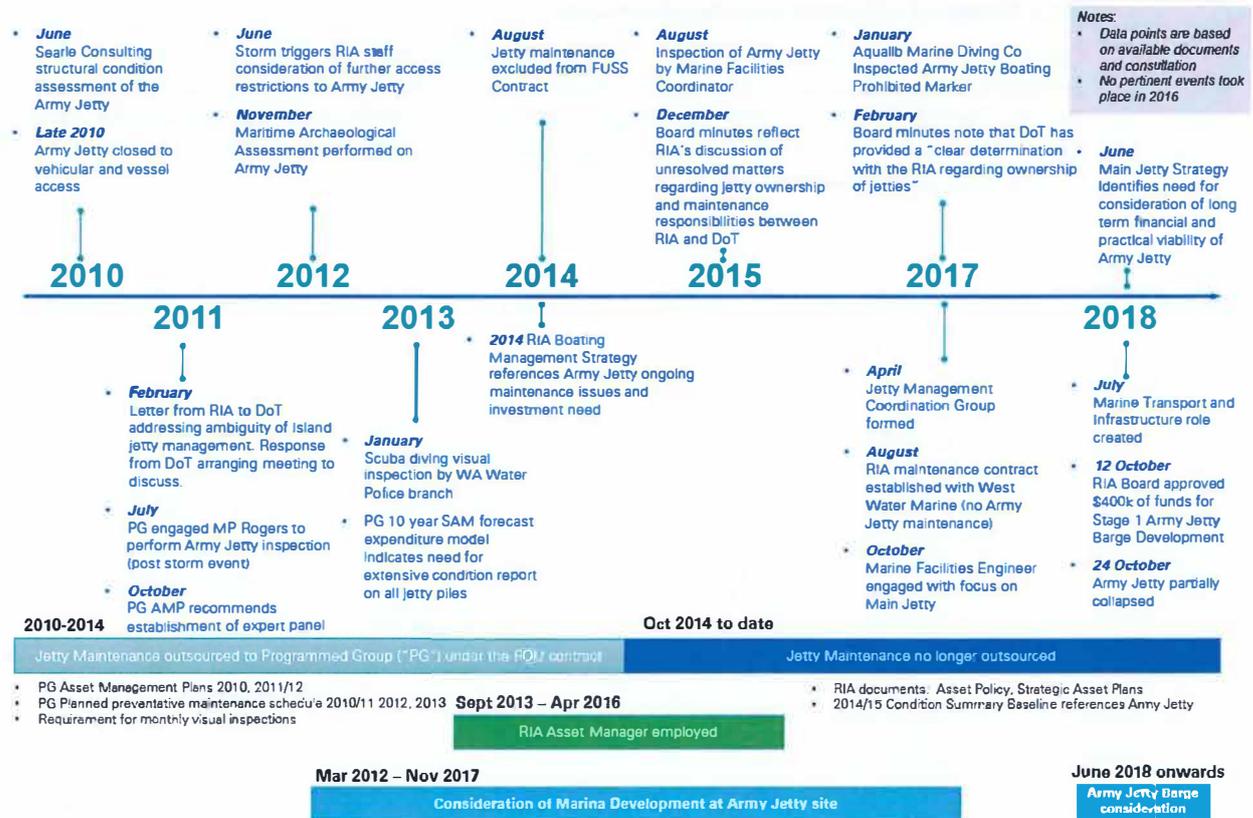
The Review Period (June 2010 to 24 October 2018) spanned approximately eight years during which time a number of inspections and assessments; and management actions related to the Army Jetty, and/or jetties in general took place. These are summarised in the following high level timeline and elaborated on in **section 2.3**.
